DESIGN 911 Centre for Porsche

Porsche 911 Convertible Top Locking Motor Gear Replacement Instructions 911-624-056-03K

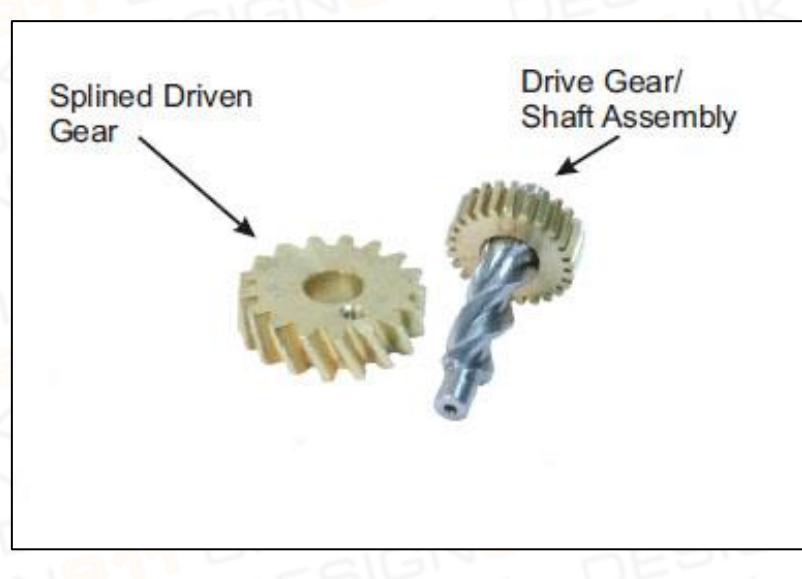
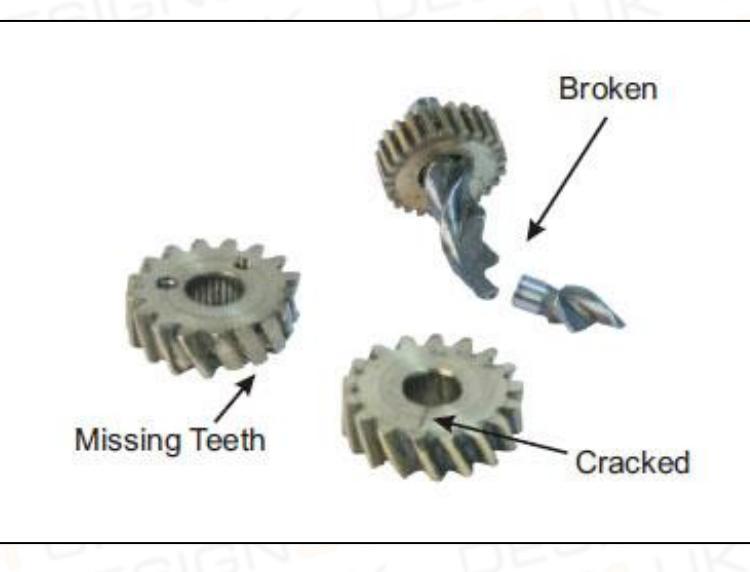
Both must be replaced and not only the damaged gear. The drive gear/shaft assembly and driven lever operating gear are subject to multiple types of failures.

The new gears are supplied as a match set.

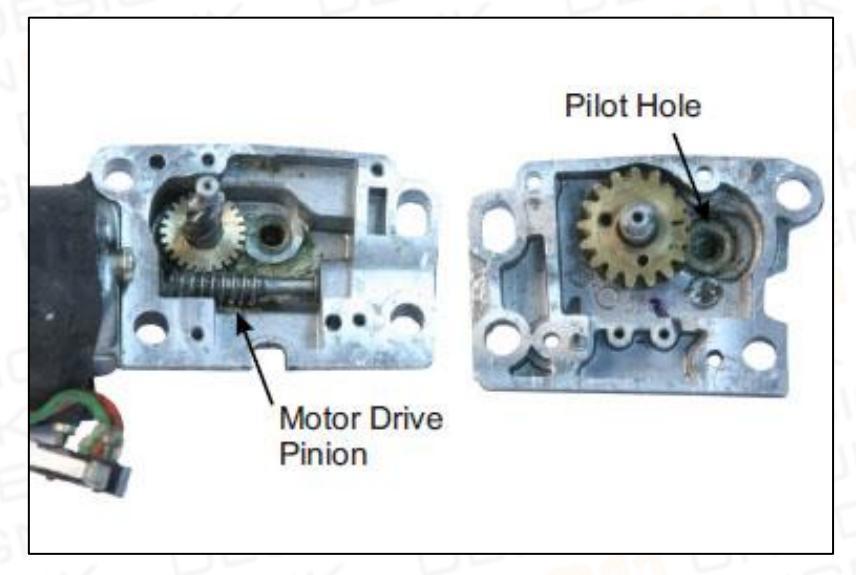
NOTE: If upon opening the cover the motor pinion worm gear on the motor shaft is broken the entire motor assembly will need to be replaced as this is not serviceable.

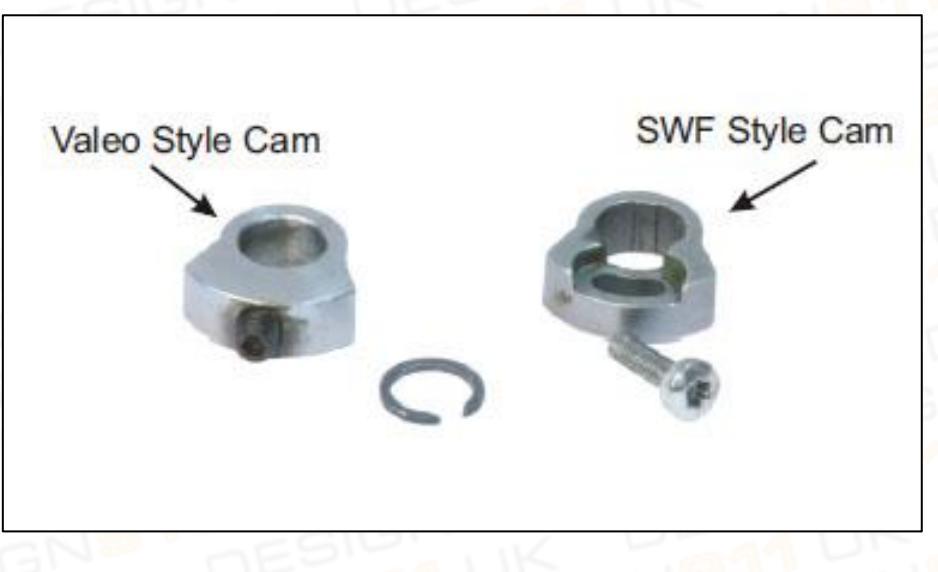
There are 2 types of activating cams depending on the brand of motor in your car. The differences are in how they are secured to the driven gear.

VERSION # 1 – found on Valeo motors has the cam retained on the shaft by a circlip and has a set screw on the face of the cam to locate its timing position.

VERSION # 2 – found on SWF motors has the cam retained by a set screw from the top of the cam into the driven gear to locate its timing position.

NOTE: the replacement large driven gear has a mounting hole for the SWF style cam but is suitable for both styles of motors.
